Airfield Damage Repair Modernization Program

AM2 Brickwork Pattern Evaluation

December 2016

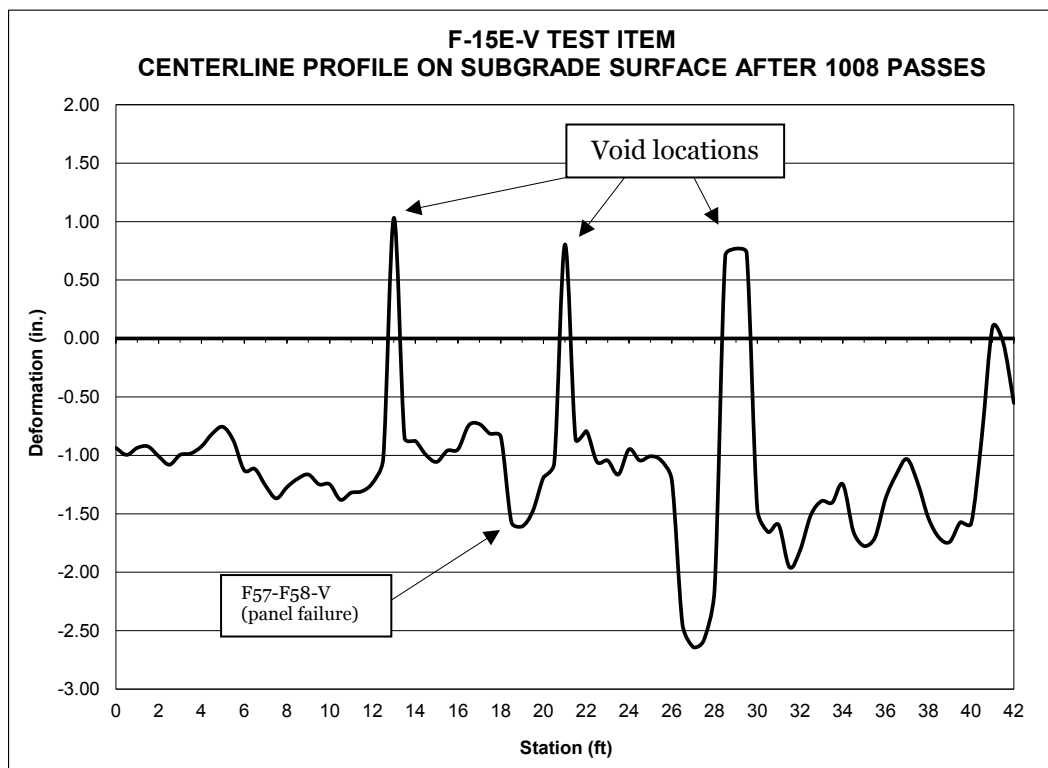
Figure 5.1. Subgrade centerline of the F-15E-V item after 1,008 passes.

In Figure 5.1, peaks observed at stations 13, 21, and 29 were the locations of voids F40-V, F64-V, and F88-V, respectively, along the centerline. The positive values are a result of rearrangement of material into the excavated void area during traffic. The initial depth of the voids was 2 in., but the depth decreased throughout traffic with the rearrangement of particles. These were ignored when determining the maximum roughness value. Stations 19 (location of void F57-F58-V) and 27 were areas of panel end connector rail failure and are represented as deep depressions in the subgrade. These were disregarded when analyzing the profile since they were associated with mat breakage and not necessarily with the system's ability (or inability) to prevent excessive roughness. Plots of the average cross-section elevation data, collected along lines A1, A2, and A3, are shown in Figure 5.3 through Figure 5.5

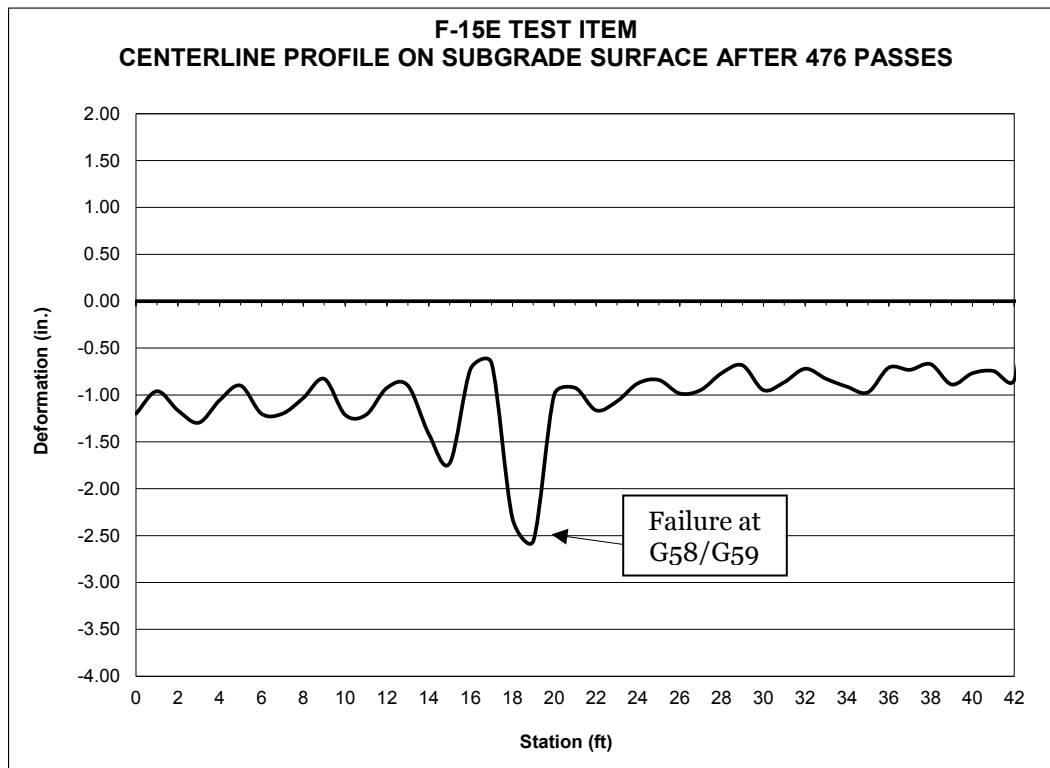
Figure 5.6. Subgrade centerline profile of the F-15E item after 476 passes.

Plots of the centerline profile data, as determined from robotic total station recordings are shown in Figure 5.6 and Figure 5.7. Stations where panel failures occurred were disregarded when analyzing the profiles. An example of this is station 18 in Figure 5.6. Plots of the average cross-section elevation data, collected along lines A1, A2, and A3, are shown in Figure 5.8 through Figure 5.10.

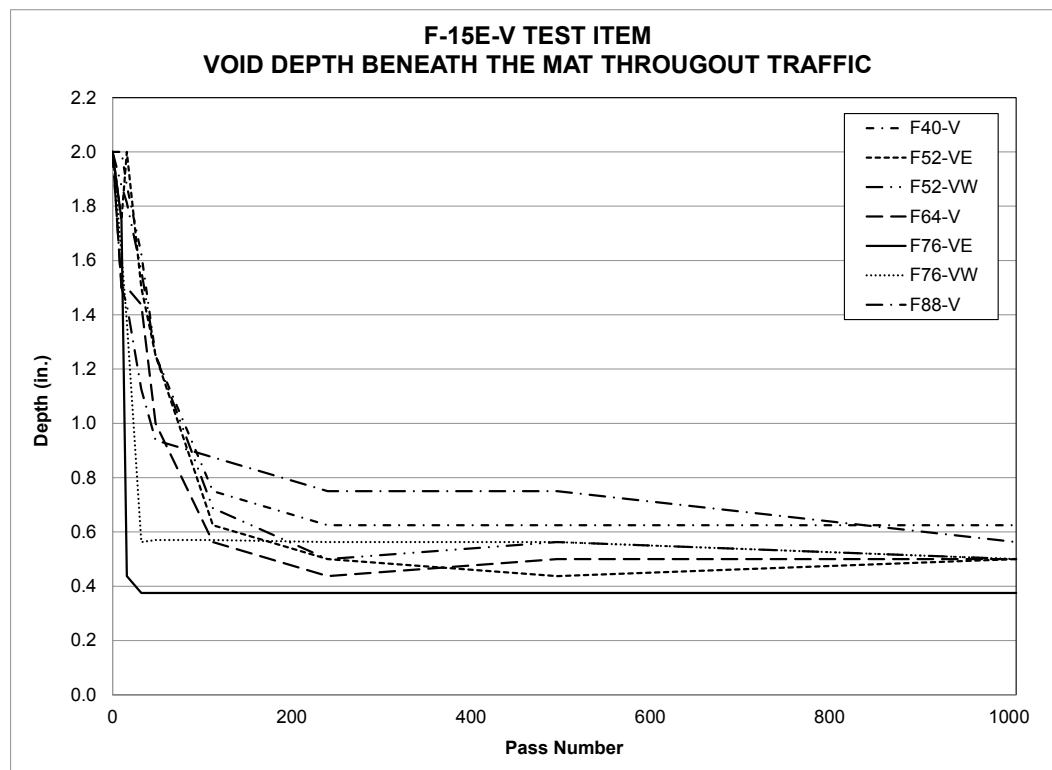
Figure 5.16. Void depth beneath the mat throughout traffic of the F-15E-V item.

In an attempt to monitor the progression of deformation where voids were excavated, observation holes were drilled in several panels at the positions where voids were located. Figure 5.16 shows the variation of the depth of the voids underneath the mat during traffic. After removing the mats, the voids were visually inspected to determine the extent of movement of material in those specific areas. It was observed that the diameter of the voids reduced and that material filled in the excavated areas, making the center of the voids nearly level and uniform with the subgrade surface. Figure 5.17 shows pretest and posttest photographs of voids F52-VW, F52-VE, and F88-V.

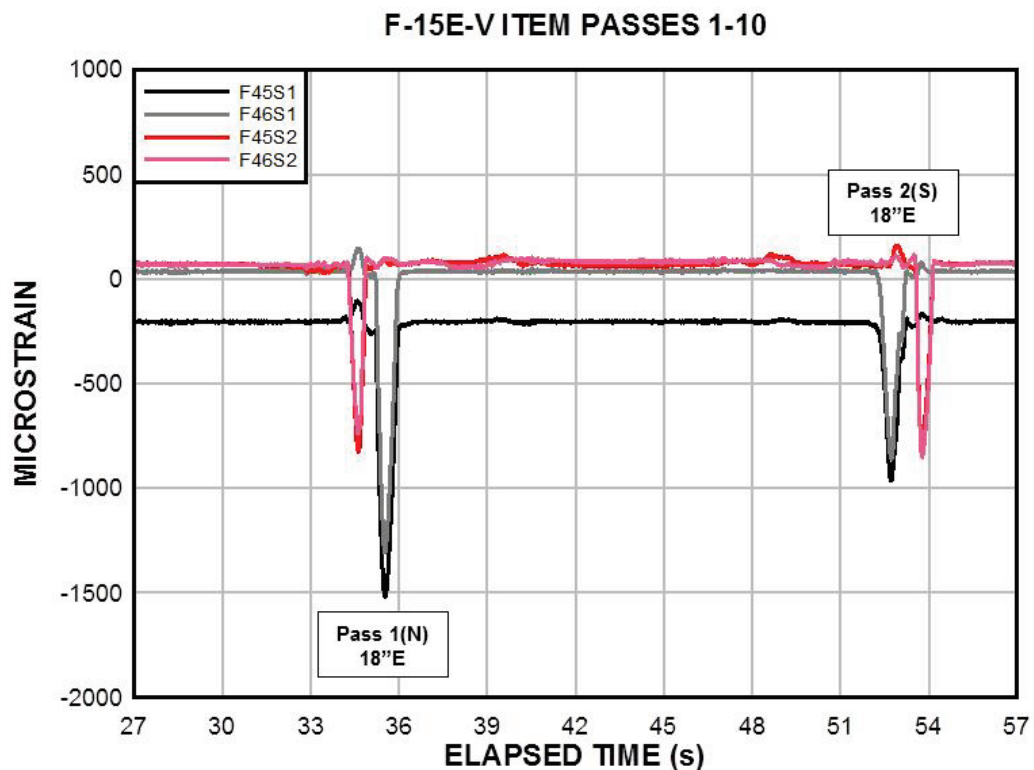
Figure 7.4. F-15E-V item F45-F46 panel joint strains for passes 1-2.

Pass 1 (northbound) and pass 2 (southbound) subset of the same data is shown in Figure 7.4. During pass 1 the load cart wheel was centered approximately 18 in. east of the joint on Panel F45. The wheel was located at the F45 south/female hinge edge first, deflecting it downward, evidenced by the compressive strains recorded for F45S2 and F46S2. At the same time the north edge of the F45 panel was being forced upward, evidenced by an increase (tensile strain direction) in the F45S1 and F46S1 strain readings. The compressive-tensile strain reading sequence was reversed during pass 2 for the F45S1-F46S1 and F45S2-F46S2 gauge pairs.

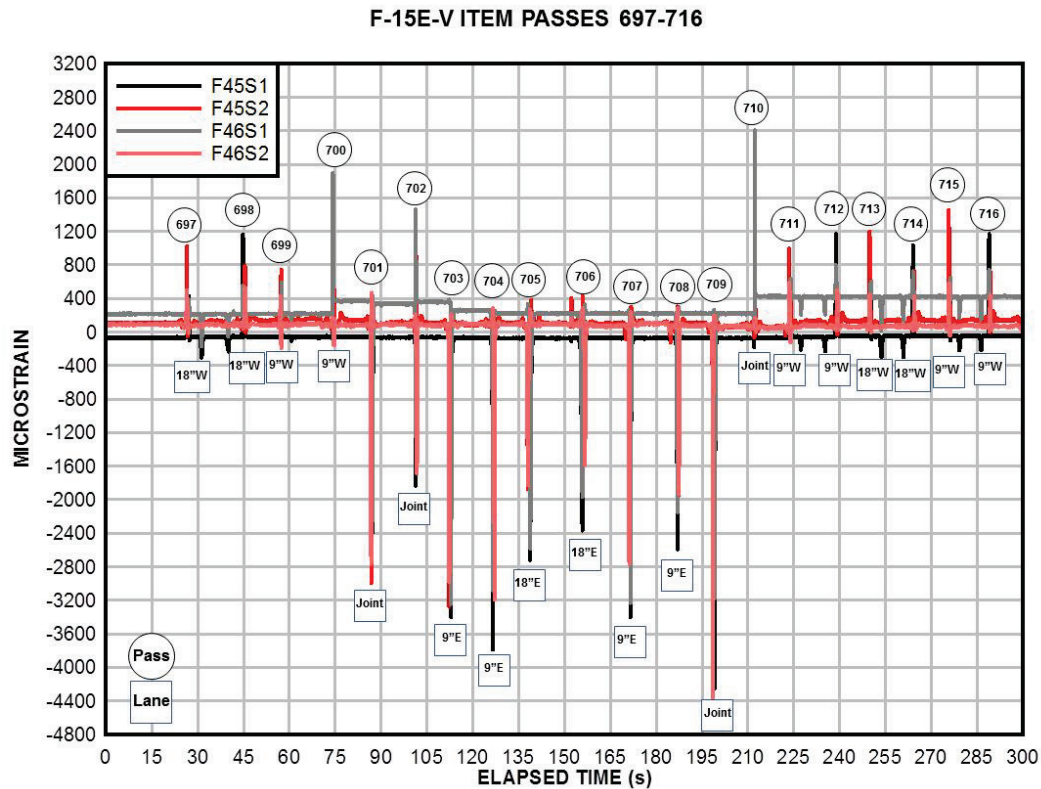
Figure 7.5. F-15E-V item F45-F46 panel joint strains for passes 697-716.

Strain magnitudes were generally higher closest to the joint during the early load cart passes, particularly for compressive strains. However, deformation of the mats and subgrade as the number of traffic passes increased created much more unpredictability in the panel movement, creating more exceptions to the theory that load applied closer to the joint yields higher magnitude strain. This observation is illustrated by the F45-F46 joint strains for passes 697-716 in Figure 7.5.

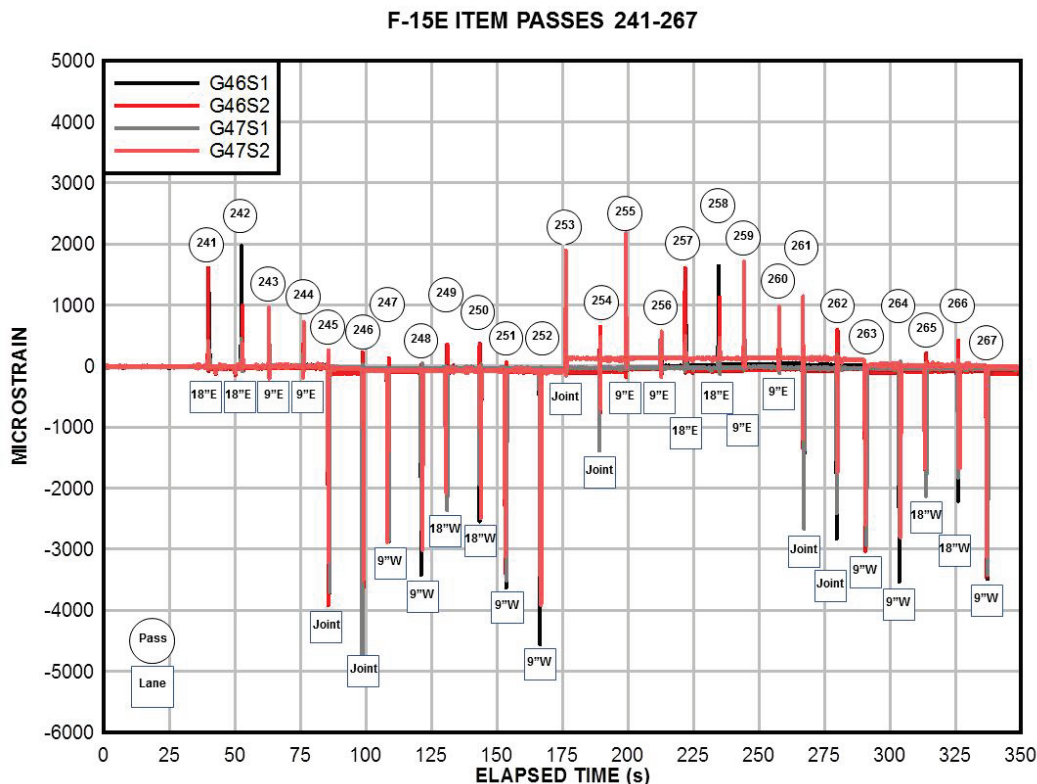
Figure 7.9. F-15E item G46-G47 panel joint strains for passes 241-267.

Strain magnitudes were generally higher closest to the joint during the early load cart passes, particularly for compressive strains. However, deformation of the mats and subgrade as the number of traffic passes increased created much more unpredictability in the panel movement, creating more exceptions to the theory that load applied closer to the joint yields higher magnitude strain. This observation is illustrated by the G46-G47 joint strains for passes 241-267 in Figure 7.9.

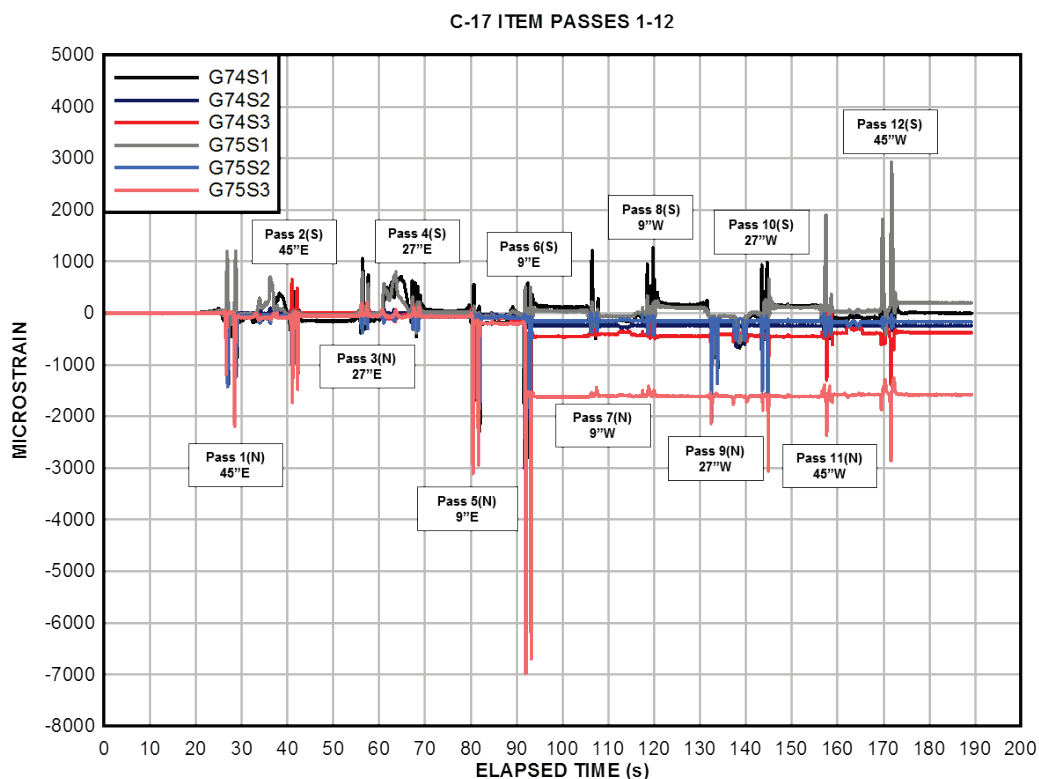
Figure 7.13. C-17 item G74-G75 panel joint strains for passes 1-12.

The G74-G75 panel joint strains in Figure 7.13 for the first 12 C-17 passes do not show a clear correlation between strain magnitude and proximity to the joint. The strain gauge measurement range was approximately $\pm 20,000$ microstrain. Measured values outside this range were indicative of gauge failure and gauge failures correlated well with the observed mat breakage results validating that the strain gauge range was appropriate.

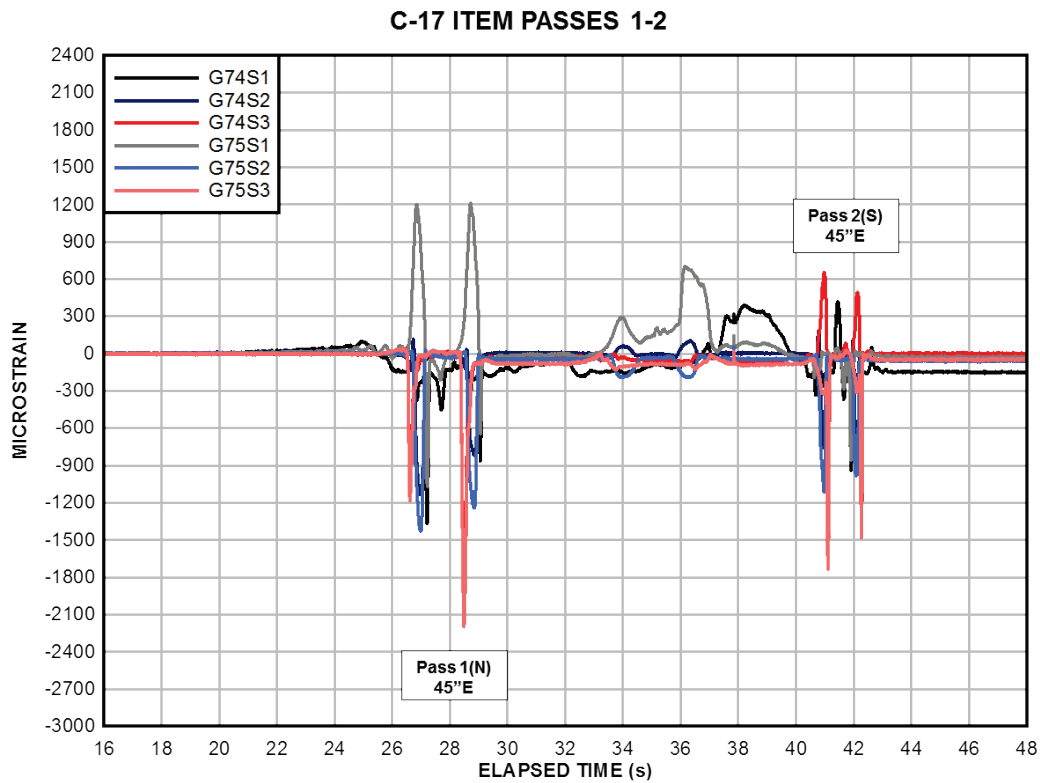
Figure 7.14. C-17 item G74-G75 panel joint strains for passes 1-2.

The pass 1 (northbound) and pass 2 (southbound) subset of the same data is shown in Figure 7.14. During these passes the load cart center wheels were centered approximately 45 in. east of the joint on Panel G74. Pass 2 panel movements predicted from the pass 1 strain data are not supported by the measured pass 2 strains, and vice versa. The unpredictability of the data was evident throughout the trafficking. The four highest strain magnitudes in the G74-G75 joint for passes 113-140 (Figure 7.15) occurred when the center wheels' line was 27 in. east, 45 in. west, 9 in. west and 9 in. east of the joint.

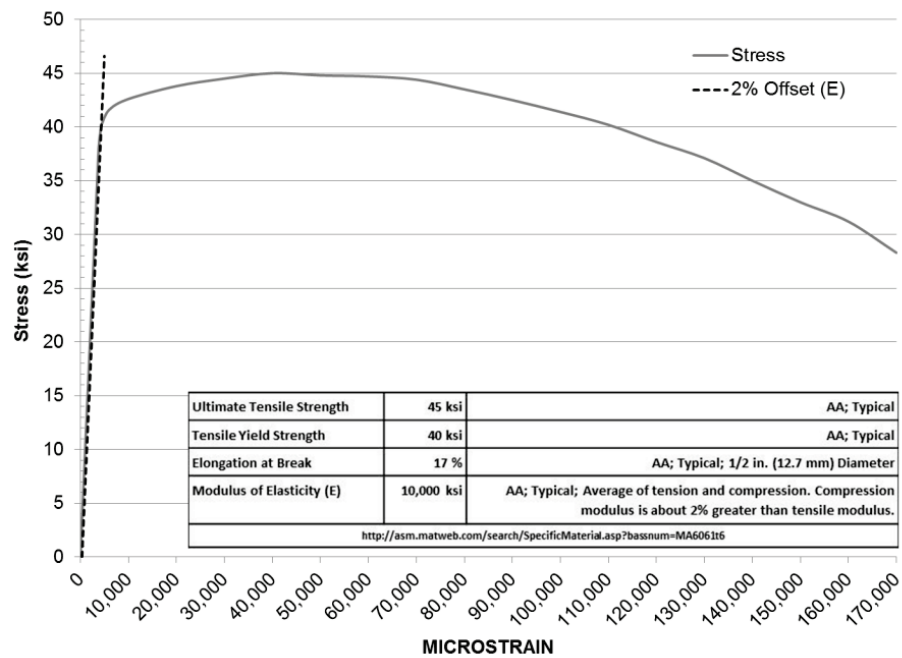
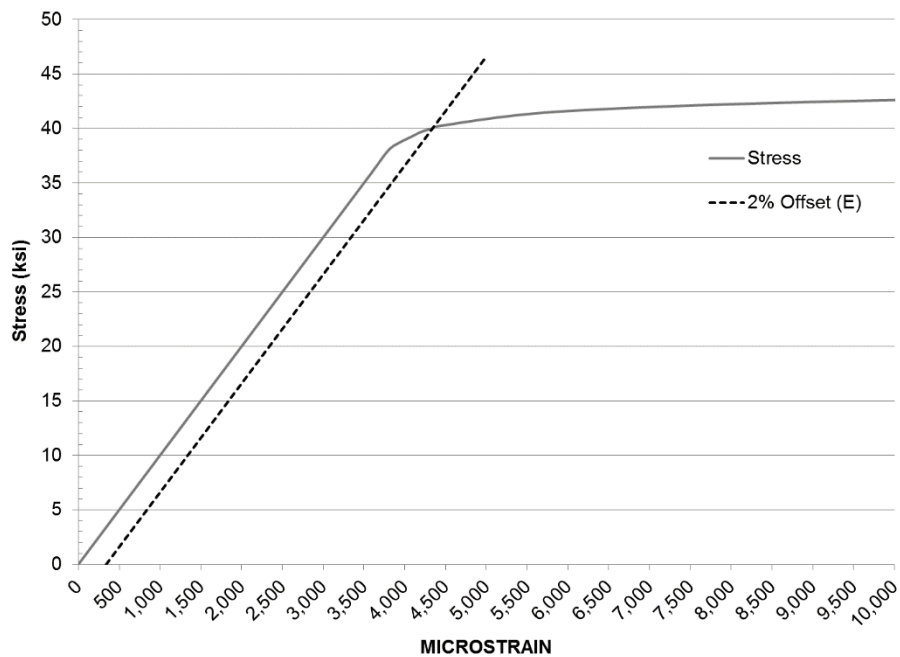
Figure 7.16. (a) Material strength properties for 6061-T6 aluminum alloy and (b) same data truncated to 10,000 microstrain.

The material strength properties for 6061-T6 aluminum are shown with a corresponding engineering stress-strain curve in Figure 7.16a. The same data truncated to 10,000 microstrain is shown in Figure 7.16b. The majority of the maximum measured strains from Table 7.1 are in the elastic range with just 3 of 15 slightly into the plastic region.

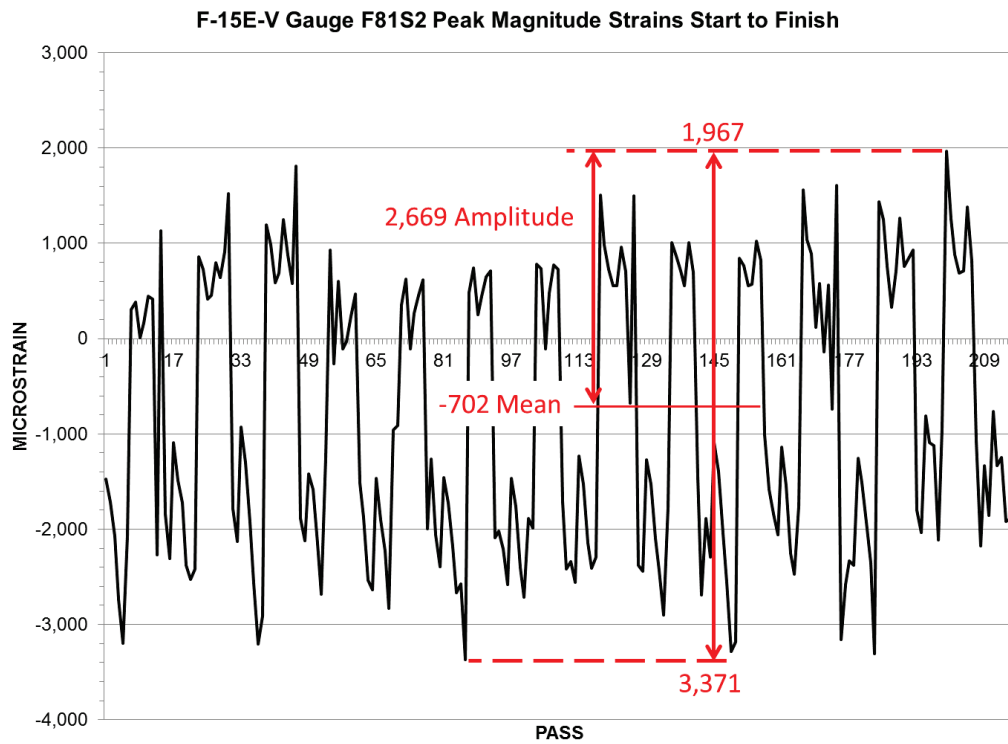
Figure 7.17. Strain amplitude for gauge F81S2.

The first strain gauge to fail was F81S2 after pass 216, and an upper prong break at this location was the first mat failure observed when trafficking paused after pass 240. The F81S2 peak magnitude strain data is shown in Figure 7.17. Strain amplitude is a key parameter in predicting material fatigue. Yahr (1997) validated Equation 1 below with 6061-T6 test data, where N is the predicted number of cycles to failure.

The predicted passes/cycles using Figure 7.17 data (2,669 microstrain amplitude) as an approximation for the cyclic strain is 27,385, much higher than the 216 passes observed from the test. This is not surprising since the strain gauges were located approximately 1.5 in. away from the end of the prongs, the points that experience the highest stress and strain during trafficking. The fact that this strain gauge failed without recording a strain outside the elastic range is most likely indicative of a failure initiated by crack propagation from the end and base of the prong, transverse to the panel.

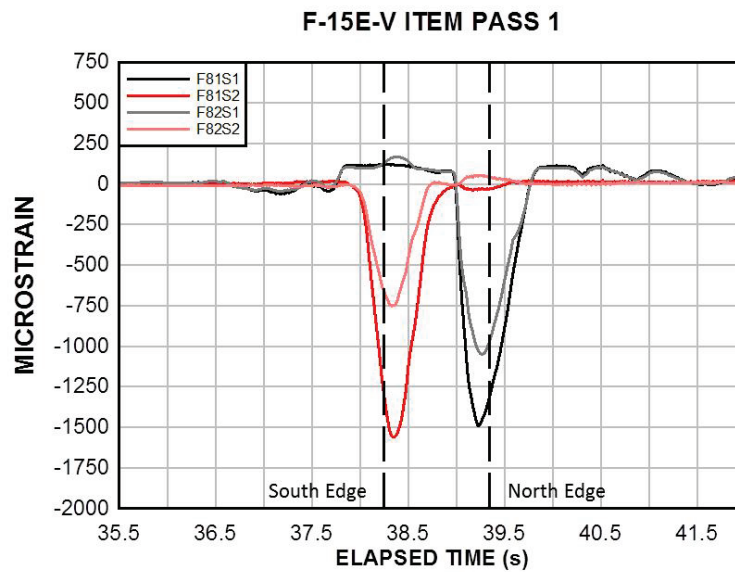
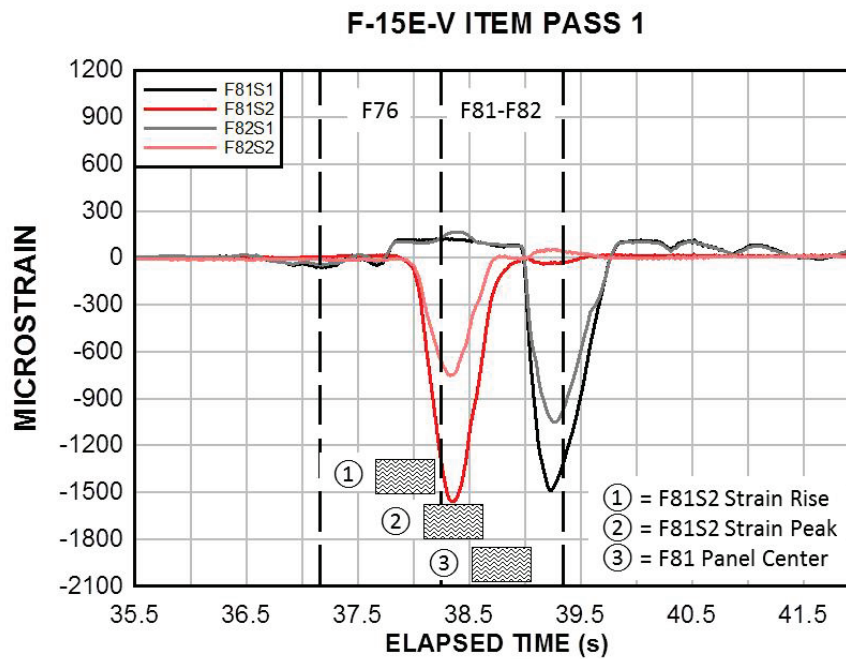
Figure 7.18. (a) F81-F82 joint strain data during pass 1 and (b) tire load footprint locations.

Figure 7.18a shows F81-F82 strains during the first traffic pass, 18 in. east of the joint. The vertical dashed lines represent the north and south hinge edges using the F81S1 and F81S2 strain peaks to establish the load cart speed, then calculating the time to travel the 2.5-in. distance from the hinge edges to each strain gauge location. The 9-in.-wide tire footprint has a 12.05-in. north-south dimension for a 35,235-lb load and 325-psi tire pressure. This 12.05-in. dimension equates to a 0.53-sec tire load duration footprint for pass 1, 18 in. east of the F81-F82 joint. Figure 7.18b shows tire load duration footprint locations, centered on the time when gauge F81S2 first measured a rising strain ①, peak strain was recorded ② and at the panel midpoint ③.

Figure 7.18 illustrates that load is transferred across the transverse joints well before the wheel hits the joint. The absence of an appreciable strain when the tire is centered on the panel confirms that the joints see the highest loads when the panels are eccentrically loaded. Each of these behaviors makes it difficult to accurately estimate an effective width for the cantilevered prongs and calculate a corresponding load or moment for a measured strain/stress.

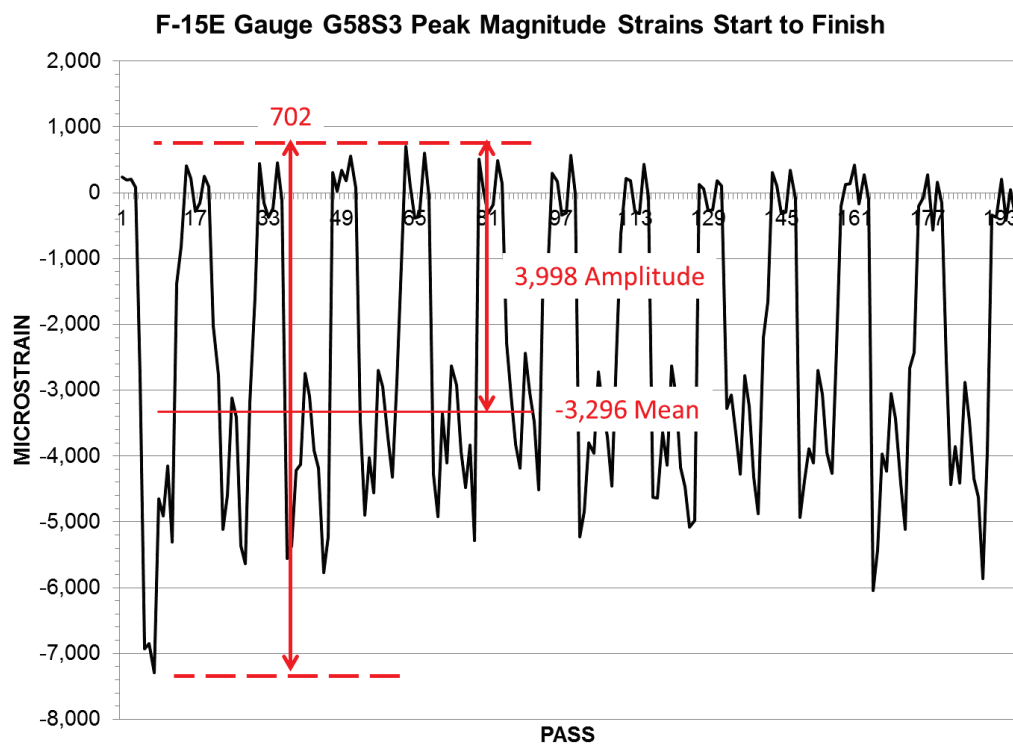
Figure 7.19. Strain amplitude for gauge G58S3.

Recall Figure 7.16 with material strength properties for 6061-T6 aluminum. Of the 19 maximum measured strains shown in Table 7.2, nine were in the plastic region. One of the first strain gauges to fail was G58S3 after pass 196, and an upper prong break at this location was the first mat failure observed when trafficking paused after pass 240. The G58S3 peak magnitude strain data are shown in Figure 7.19.

From Equation 1 (Yahr 1997), the predicted passes/cycles using the Figure 7.19 data (3,998 microstrain amplitude) as an approximation for the cyclic strain is 6,634, much higher than the 196 passes observed from the test result. This is not surprising since the strain gauges were located approximately 1.5 in. away from the end of the prongs, the points that experience the highest stress and strain during trafficking.

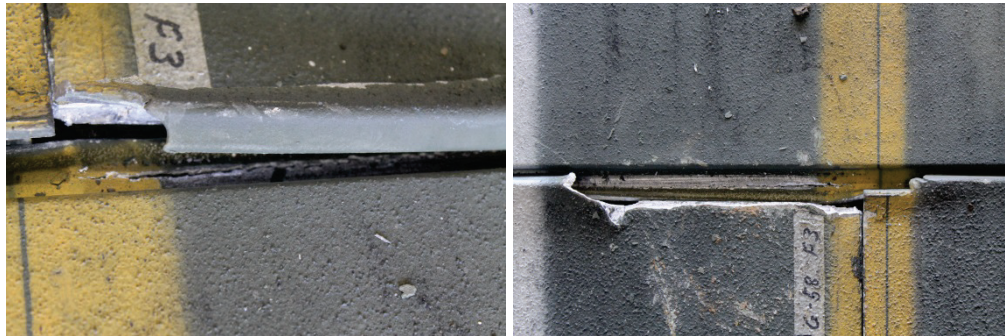
Figure 7.20. Joint of Panels G58 and G53.

Figure 7.20 shows a failure in the female hinge edge transferring load between G58 and G53. The highest G58S3 strains occurred in the first 16-pass cycle and then dropped by 18 to 35 percent before failing. Failure in the female hinge is the most likely cause for this reduction at the strain gauge, transferring more load to the underlying clay on subsequent passes.

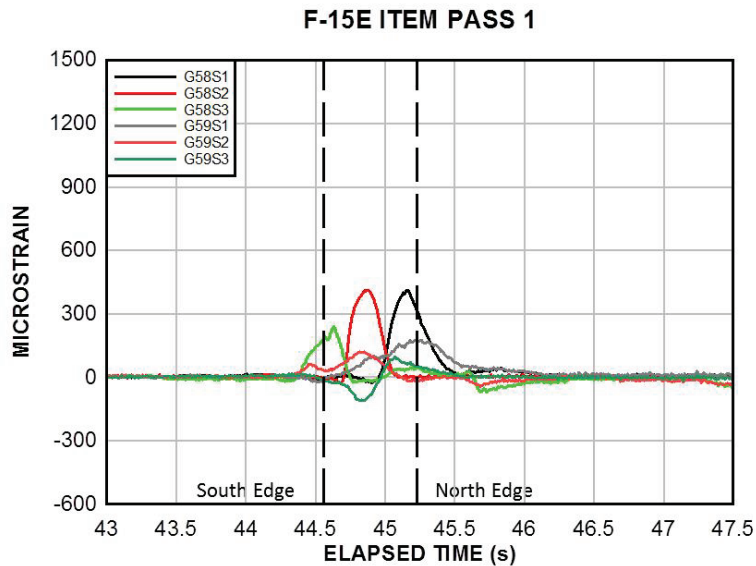
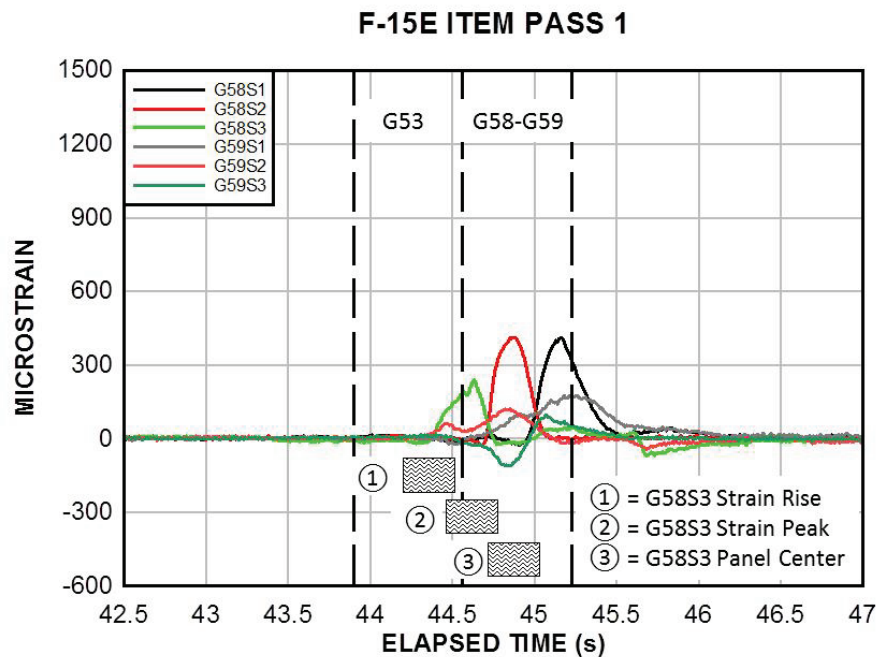
Figure 7.21. (a) G58-G59 joint strain data during pass 1, and
(b) tire load footprint locations.

Figure 7.21a shows G58-G59 strains during the first traffic pass, 18 in. east of the joint. The vertical dashed lines represent the north and south hinge edges using the G58S1 and G58S3 strain peaks to establish the load cart speed, then calculating the time to travel the 2.5-in. distance from the hinge edges to each strain gauge location. The 9-in.-wide tire footprint has a 12.05-in. north-south dimension for a 35,235-lb load and 325-psi tire pressure. This 12.05-in. dimension equates to a 0.32-sec tire load duration footprint for pass 1, 18 in. east of the G58-G59 joint. Figure 7.21b shows tire load duration footprint locations, centered on the time when gauge F81S2 first measured a rising strain ①, peak strain was recorded ② and at the panel midpoint ③.

Figure 7.21 illustrates that load is transferred across the transverse joints well before the wheel hits the joint. The absence of an appreciable strain on the end gauges when the tire is centered on the panel confirms that the joint ends see the highest loads when the panels are eccentrically loaded. As expected, the center gauge records the peak strain when the wheel is centered on the panel. Each of these behaviors makes it difficult to accurately estimate an effective width for the cantilevered prongs and calculate a corresponding load or moment for a measured strain/stress.

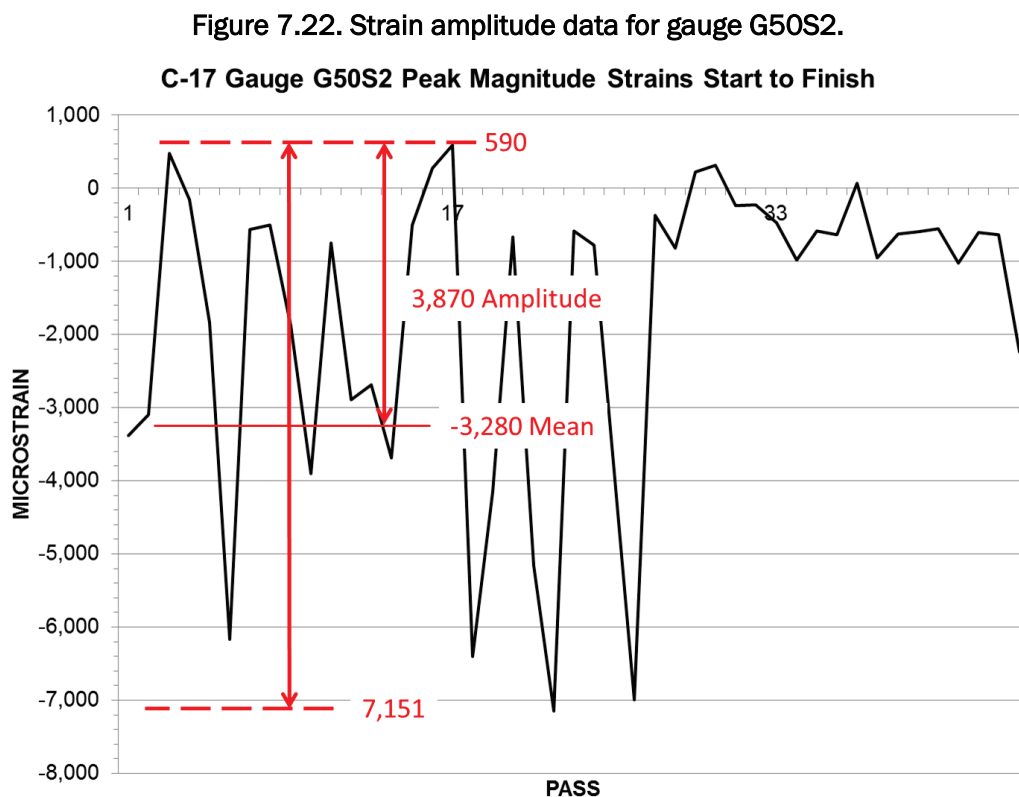
Figure 7.16 shows material strength properties for 6061-T6 aluminum. Of the 19 measured strains shown in Table 7.4, nine were in the plastic region. One of the first strain gauges to fail was G50S2 after pass 45, and an upper prong break on this panel was the first mat failure observed when trafficking stopped after pass 168. The G50S2 peak magnitude strain data are shown in Figure 7.22

From Equation 1 (Yahr 1997), the predicted passes/cycles using the Figure 7.22 data (3,870 microstrain amplitude) as an approximation for the cyclic strain is 7,228, much higher than the 90 passes observed from the test result (45 passes, each with 2 loading cycles). This is not surprising since the strain gauges were located approximately 1.5 in. away from the end of the prongs, the points that experience the highest stress and strain

during trafficking. It is interesting to note that the measured strain magnitudes during the second 28-pass cycle were significantly lower than the first, yet the end result was a gauge failure and likely a material failure.

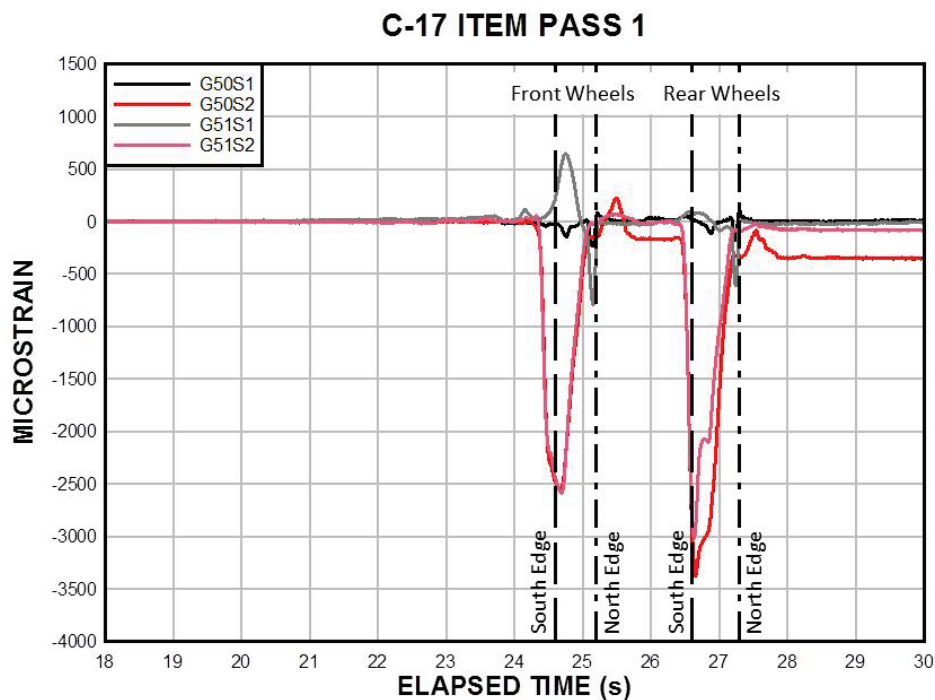
Figure 7.23. G50-G51 joint strain data during pass 1.

Figure 7.23 shows G50-G51 strains during the first traffic pass, 45 in. east of the joint. The vertical dashed lines represent the north and south hinge edges using the G50S1 and G50S2 strain peaks to establish front and rear wheel load cart speeds, then calculating the time to travel the 2.5-in. distance from the hinge edges to each strain gauge location.

The pronounced single data peak suggests that the offset lead and trailing two tires for each set of three wheels interact with the matting similar to a single axle of three wheels and a tire contact area larger than one wheel but less than two in line wheels. This graphic illustrates that load is transferred across the transverse joints well before the wheel hits the joint. It is not possible to determine accurate tire locations using the strain data or to accurately estimate an effective width for the cantilevered prongs and calculate a corresponding load or moment for a measured strain/stress.
